**SACRAMENTO RIVER FLOOD CONTROL PROJECT,
CALIFORNIA
MID-VALLEY AREA, PHASE III**

**DESIGN MEMORANDUM
VOLUME I OF II**

**US Army Corps
of Engineers**

June 1996

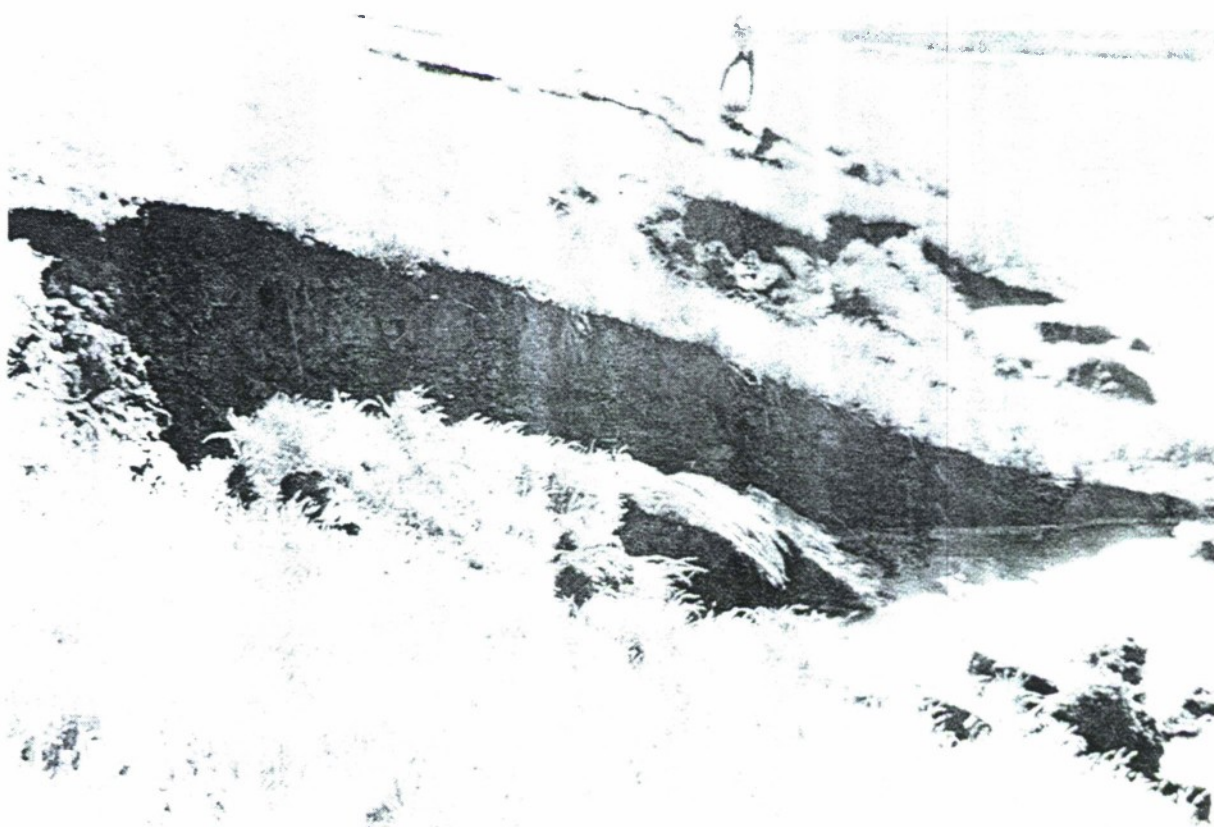
Sutter Bypass. - The west levee of Sutter Bypass just east of Robbins was the site of significant seepage and settlement in February 1986 (see Figures 1, 2, and 3). The problem began suddenly as a blowout of levee embankment toe material. Erosion of the landside levee toe continued until the levee embankment subsided at the site. Seepage water then appeared immediately downstream, eroding levee material until this too was stopped by settlement of the levee. The process continued downstream for about 200 feet. Emergency flood fight efforts (see Figure 2) were initiated by the Corps of Engineers to stabilize the levee embankment. A temporary waterside berm about 50 feet wide and 300 feet long was constructed of sand and gravel at a cost of about \$290,000. Upstream from this site (in the vicinity of Highway 113), numerous clear water boils have occurred along about 1 mile of levee during past high flows. Two of these boils, identified as boil numbers 12 and 16, have occurred regularly enough to have acquired numbers

LEVEE EMBANKMENT PROBLEM AREAS ON WEST LEVEE SUTTER BYPASS
DURING FEBRUARY 1986 FLOOD.

(numbered staffs at each boil). One of these boils has a permanently installed corrugated metal standpipe to control flow. On the east side of Sutter Bypass, seepage waters appear landward of the levee during high flood stages from the Natomas Cross Canal upstream along about 8 miles of levee. Significant seepage and small boils have occurred along this levee just upstream from the cross canal. The levee embankment also failed in this same area (see Plate 3 for location) in the past.

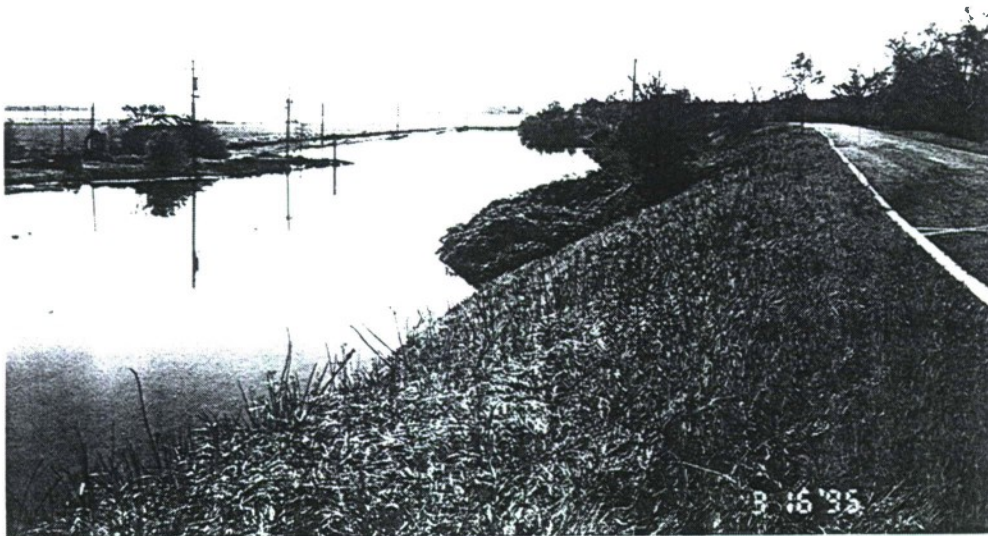
IN 1995, POND CREATED FROM EXTENSIVE SEEPAGE ALONG
LEVEE TOE AT SITE 18, FEATHER RIVER/YOLO BYPASS.
LAST TIME WATER PONDED HERE WAS IN 1985.

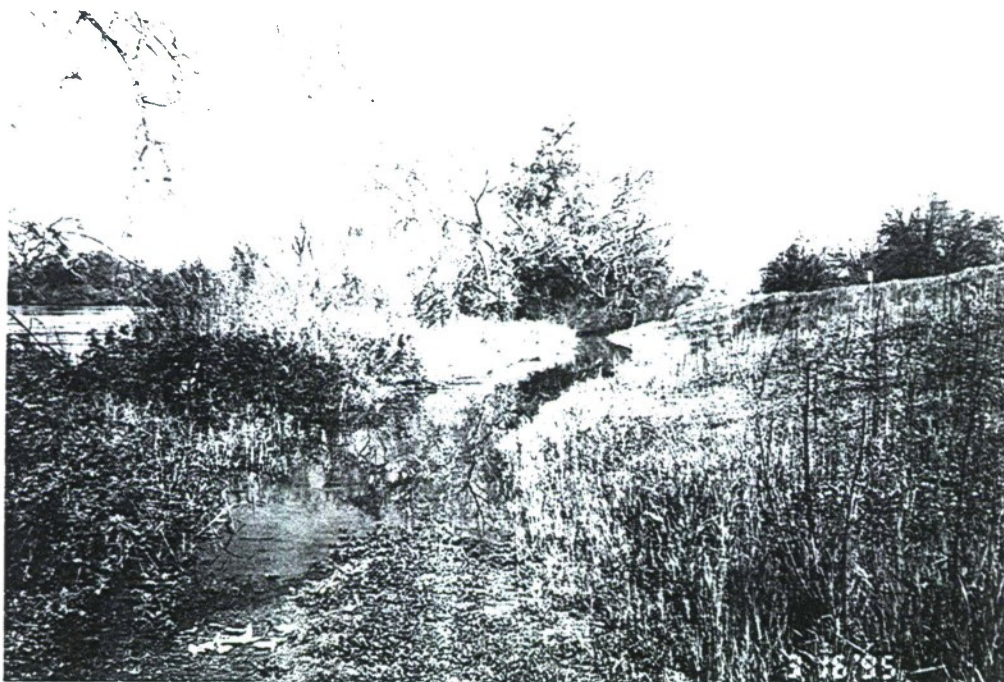
SITE 17 WATERSIDE VIEW MARCH 16, 1995
OPPOSITE OLD LEVEE BREAK POND.

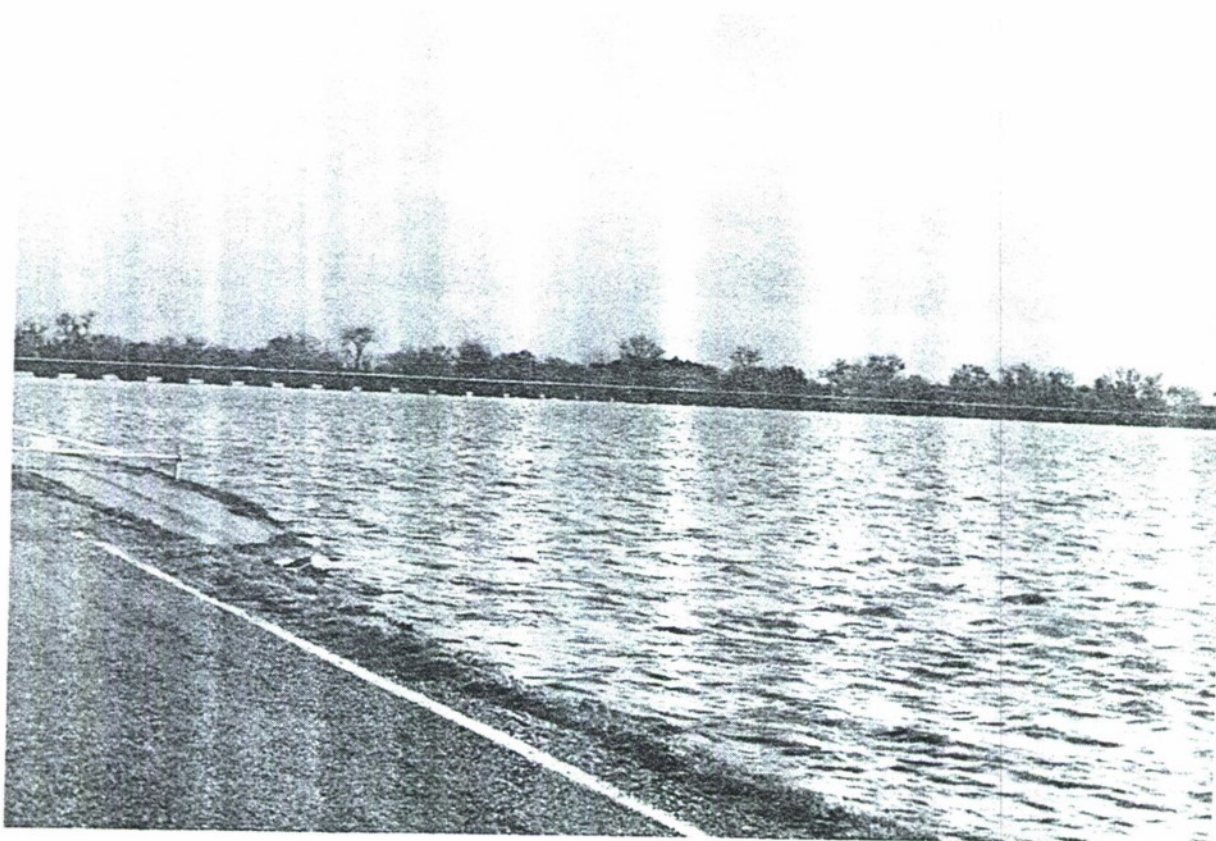
FEBRUARY 1986 FLOODFLOWS EXCEEDED DESIGN CONDITIONS
FOR SACRAMENTO WEIR AND BYPASS.
